STRUCTURES INSPECTION FIELD REPORT

B-16-053

CITY/TOWN BOSTON		8-STRUCTURE NO. B16053-4T3-DOT-NBI		11-Kilo. POINT 212.910	41-STATUS A:OPEN	90-ROUTINE INSP. DATE MAR 30, 2022
07-FACILITY CARRIED HWY BROOKLINE AV		MEMORIAL NAME/LOCAL NAME David Ortiz "Big Papi" Bridge		27-YR BUILT 1965	106-YR REBUILT 1998	YR REHAB'D (NON 106) 0000
06-FEATURES INTERSECTED COMB I 90 & MBTA/CSX		26-FUNCTIONAL CLASS Urban Arterial		DIST. BRIDGE INSPECTION ENGINEER J. O'Connor		
43-STRUCTURE TYPE 302 : Steel Stringer/Girder		22-OWNER State Highway Agency	21-MAINTAINER State Highway Agency	TEAM LEADER M. Tetreault		
107-DECK TYPE 1 : Concrete Cast-in-Place		WEATHER Clear	TEMP. (air) 5°C	TEAM MEMBERS M. HAILU, M. ZEROUAL

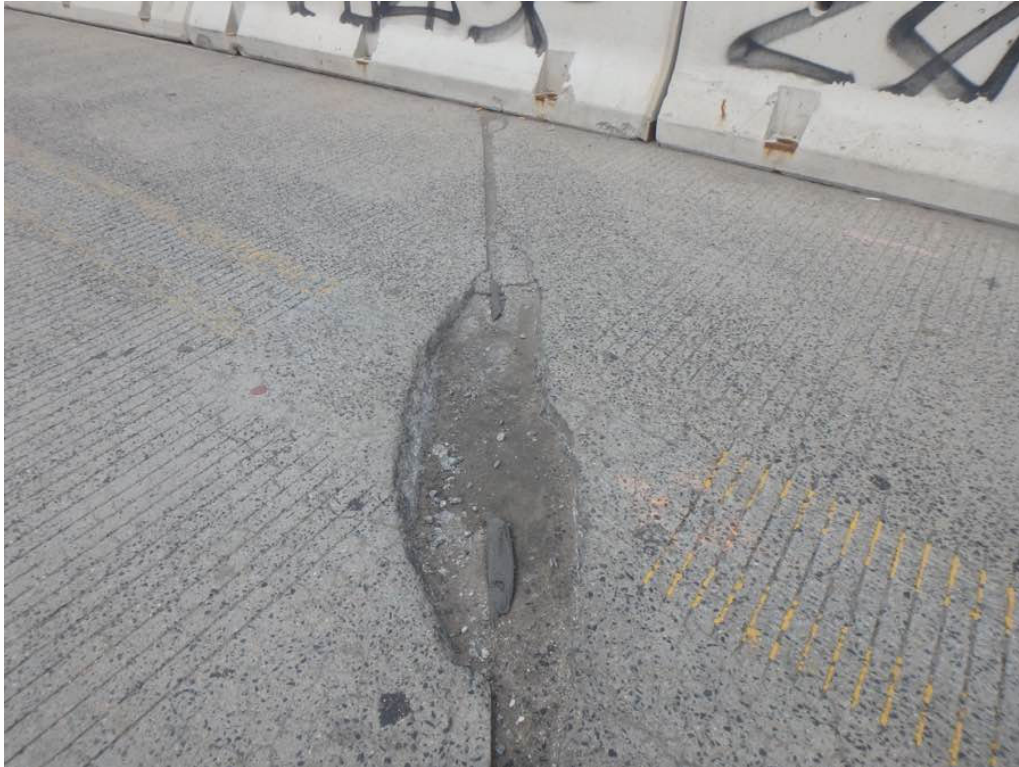
In all three spans there is a hairline to light longitudinal crack 1-1/2' from the center of roadway. In span #1 there is moderate spalling, 3'L x 8"W x 2"D with the concrete breaking up by the center of roadway at pier #1. **See Photo #1.** In span #2 there is a moderate transverse crack, 10' from the west curb, at pier #1. There is a concrete spill in span #2, almost full-length. There is minor spalling adjacent to the west curb at the north abutment.

Photo 1: The deck above pier #1 has moderate spalling near midspan

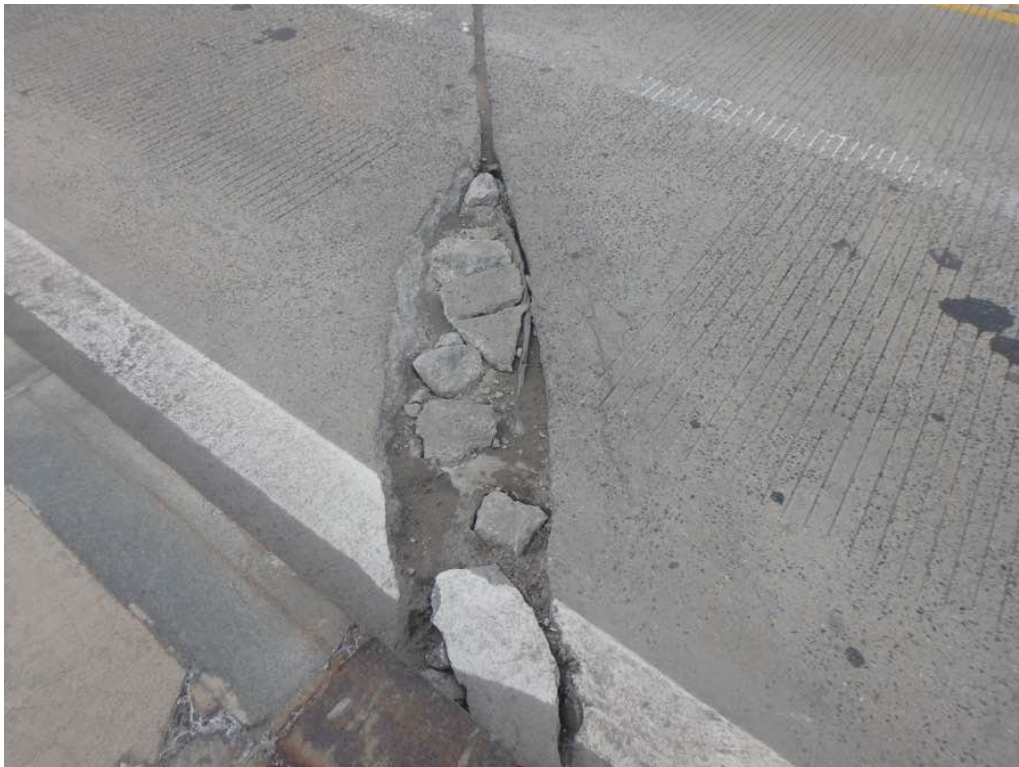
Above pier #1 by the east curb, there is a heavy spall at the joint, 5'L X 1'W X 3"D. **See Photo #2.** In span #2 by pier #2 and in span #3 at pier #2 there are minor spalls by the center of roadway.

Photo 2: The deck above pier #1 has heavy spalling at the east end

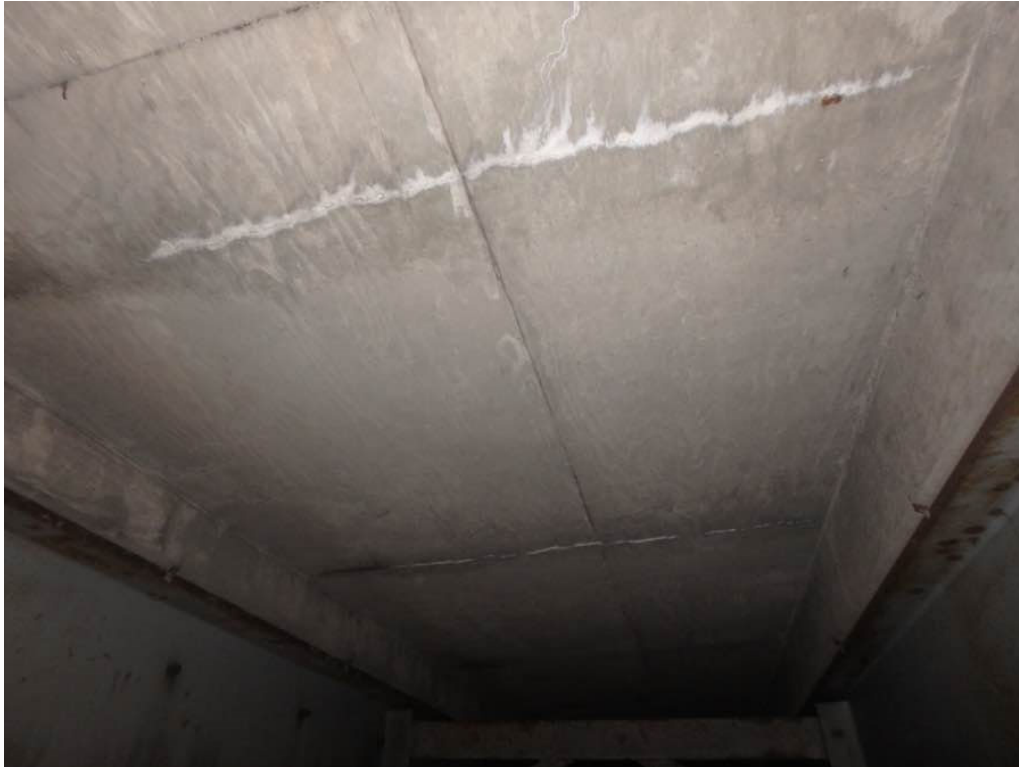
Bays #4 and #8 are exposed concrete in all three spans. There are numerous hairline transverse cracks with minor efflorescence throughout in bay #8 in all three spans. **See Photo #3.** In bay #4 there are numerous hairline transverse cracks with minor efflorescence in spans #2 and #3.

Photo 3: There is typical transverse cracks with minor efflorescence in bay #8 (span #3 shown)

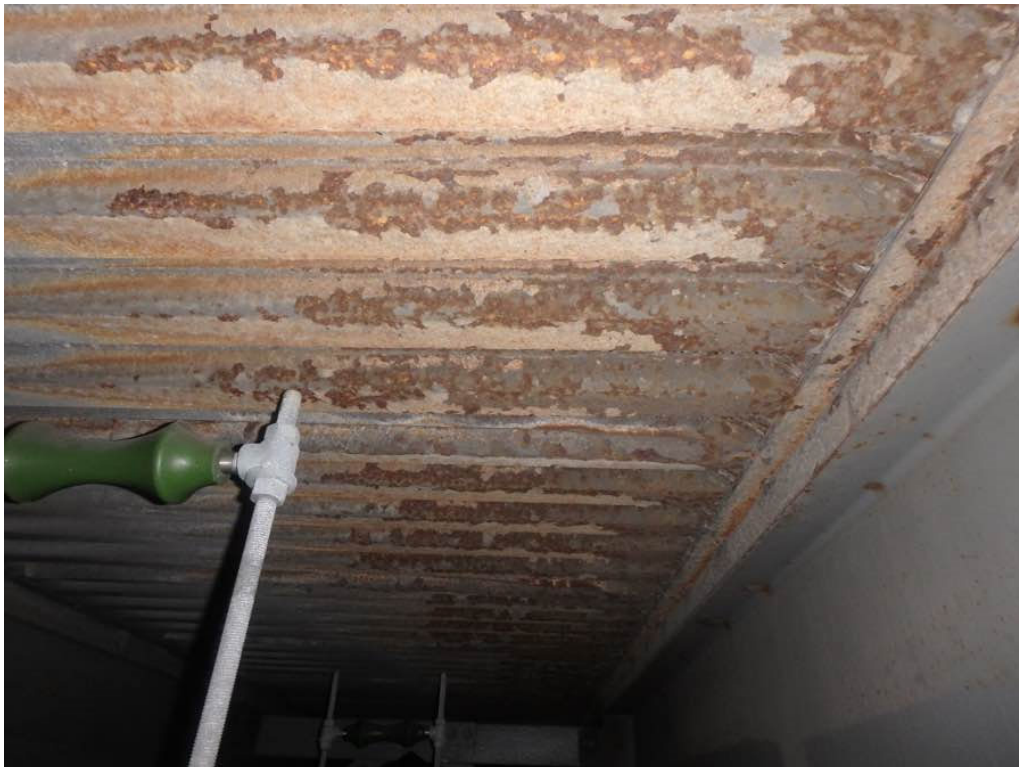
The SIP forms have a pocket of moderate rusting adjacent to beam #3 at the south abutment in span #1. There is moderate rusting at the edges of the SIP forms in span #2 by pier #1. In spans #2 and #3 there is random minor to moderate rusting of the SIP forms, primarily at the edges. **See Photo #4.**

Photo 4: There is typical minor to moderate surface rusting of the SIP forms (bay #3 in span #3 shown)

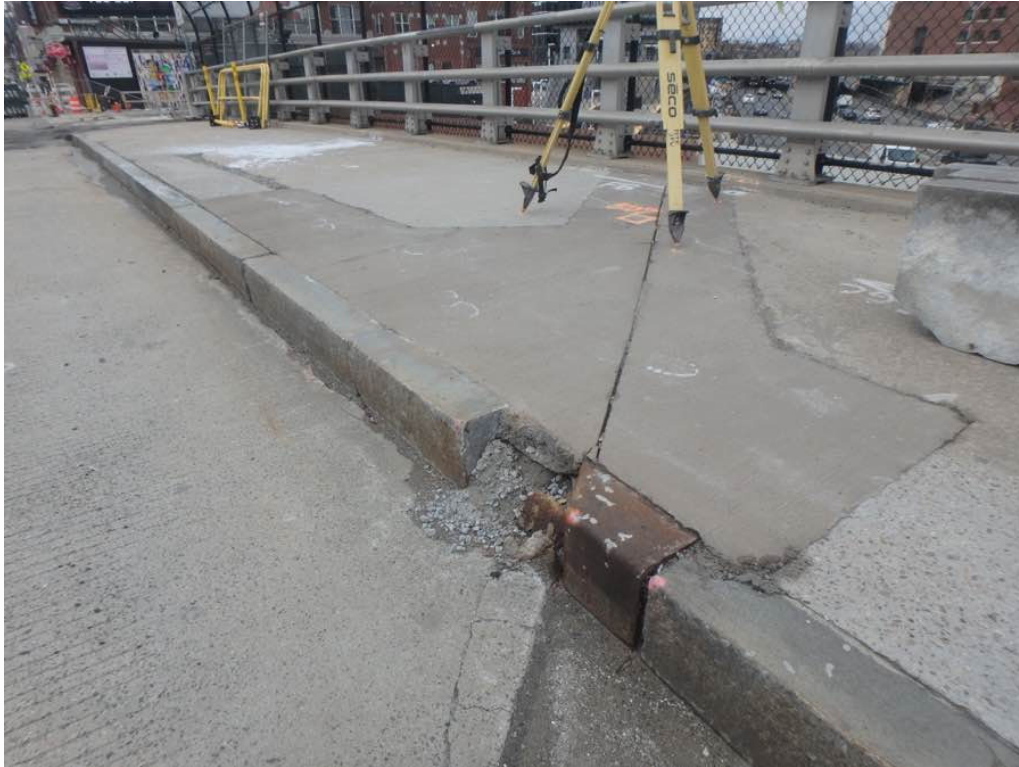
The west curb at sections #2 and #3 from the south have diagonal through cracks. At pier #1 there is a small section of granite curb missing. **See Photo #5.**

Photo 5: Concrete patch in the west sidewalk at pier #1, small section of granite curb missing

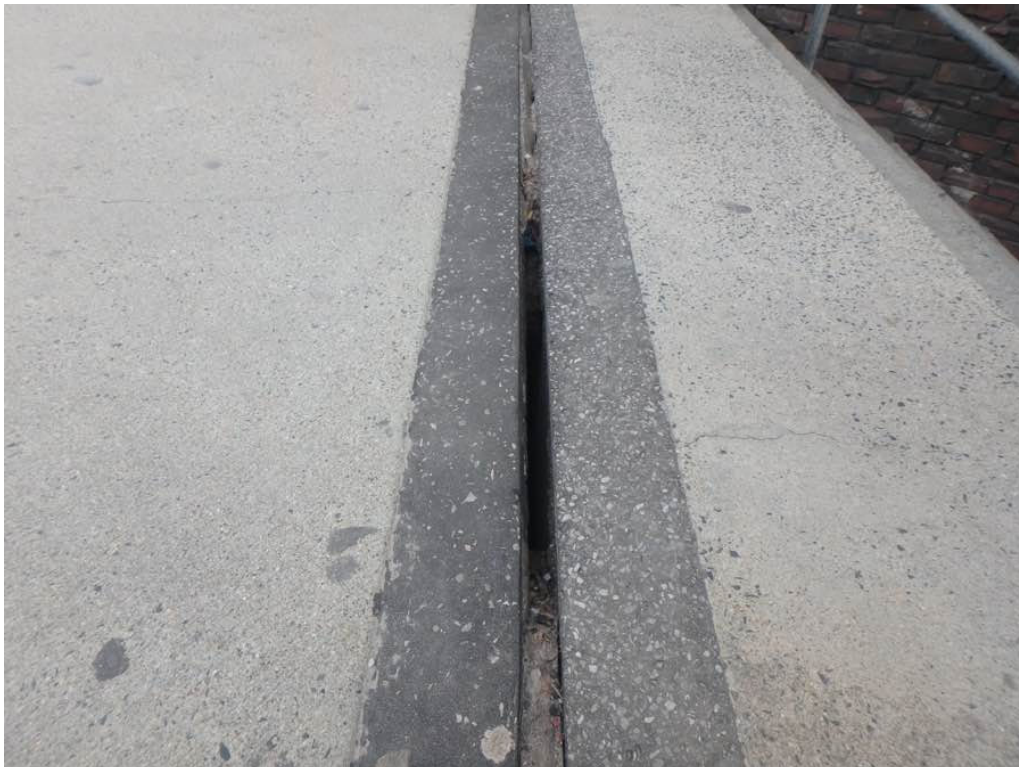
At the south abutment deck joint there is a 2'-2" long section of the filler material missing with adjacent adhesion failure to the existing filler. **See Photo #6.** There is minor scaling inside the curbing and hairline to light diagonal cracks by the south abutment.

Photo 6: There is a section of missing joint filler and adjacent adhesion failure at the east sidewalk over the south abutment

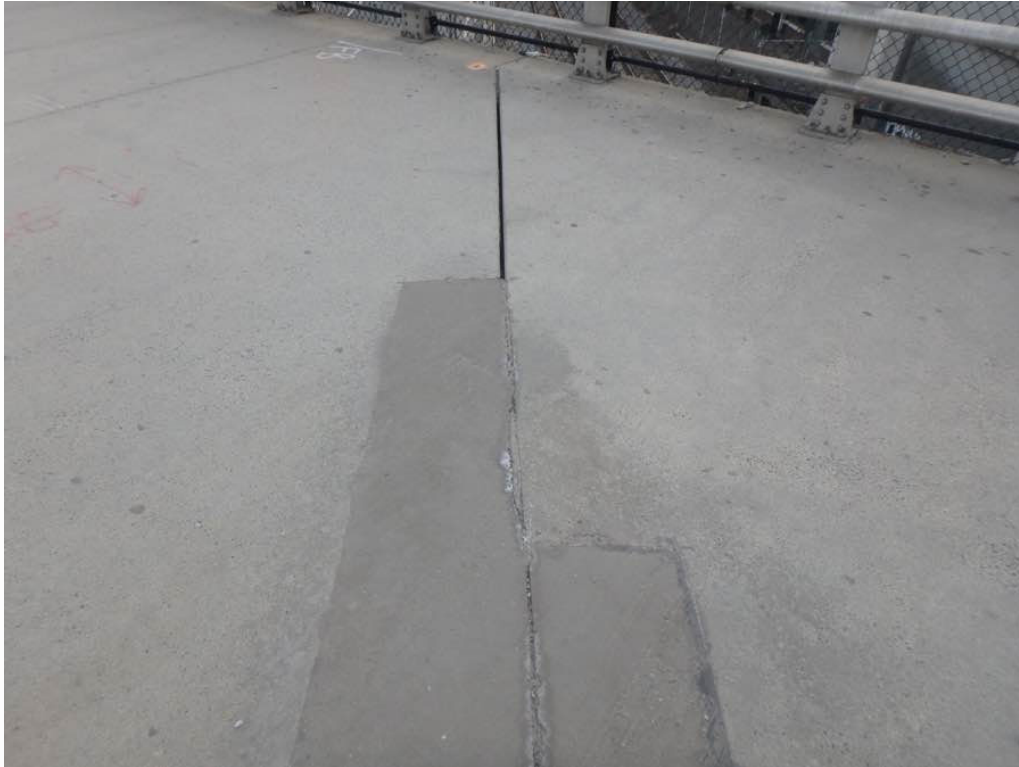
Photo 7: The east sidewalk at pier #1 has concrete repair

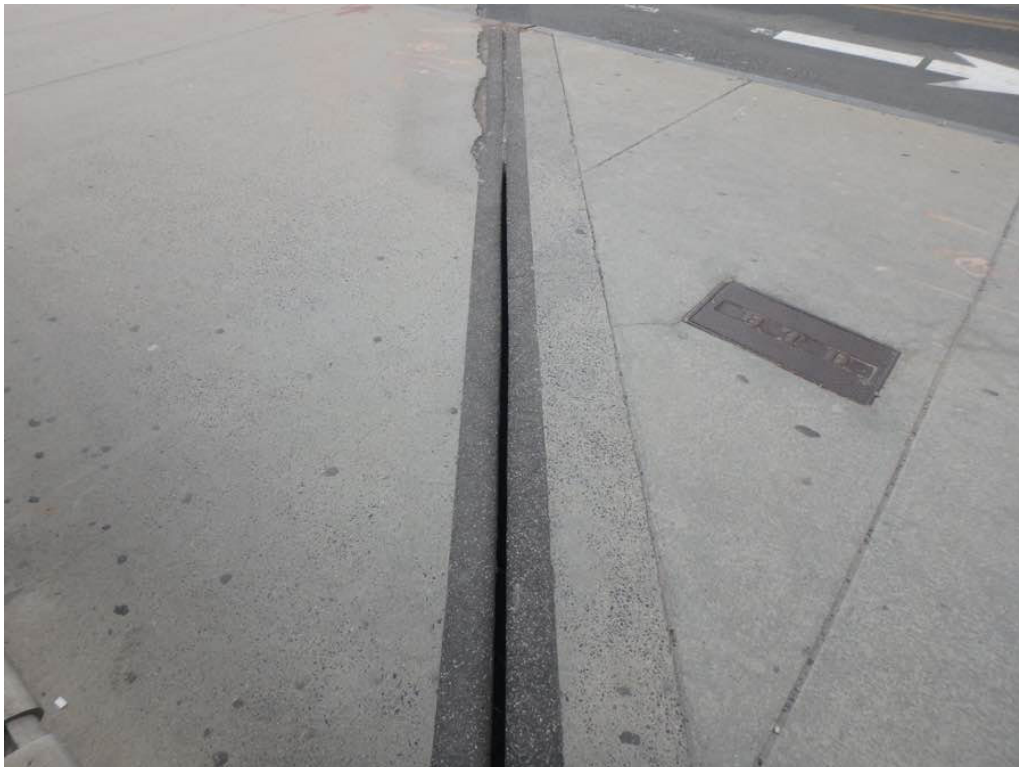
At the north abutment the filler at the deck joint is missing, 10' long. **See Photo #8.**

Photo 8: The north abutment joint has filler missing at the east sidewalk

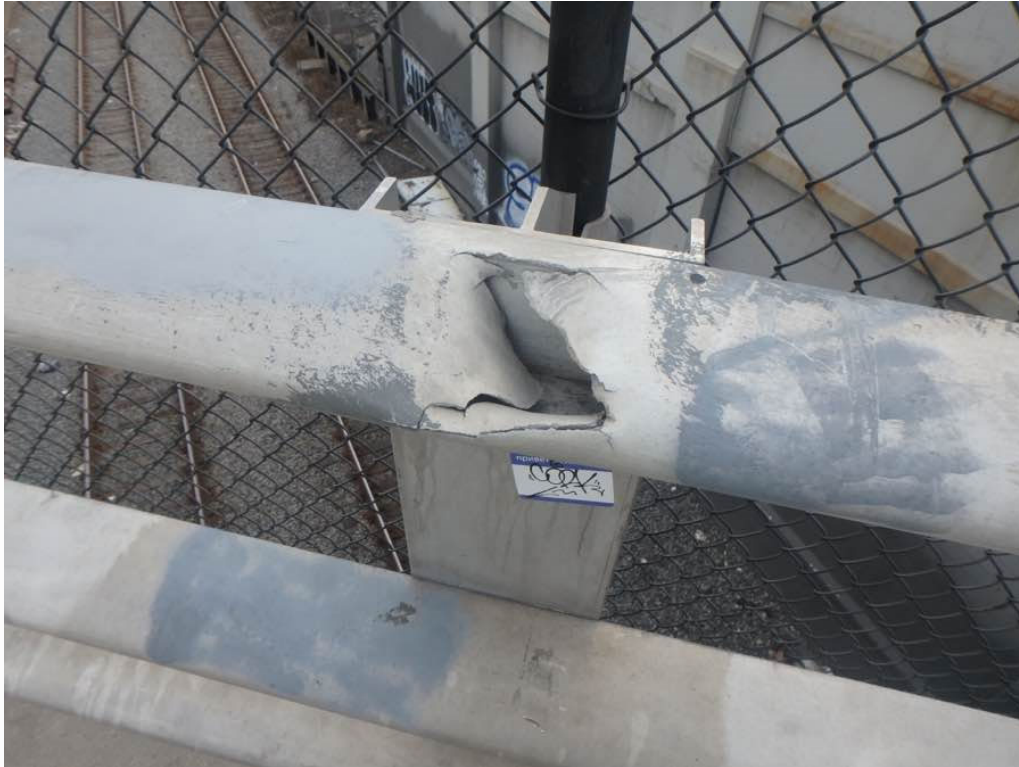
Photo 9: The east railing has a puncture in the top rail at post #4

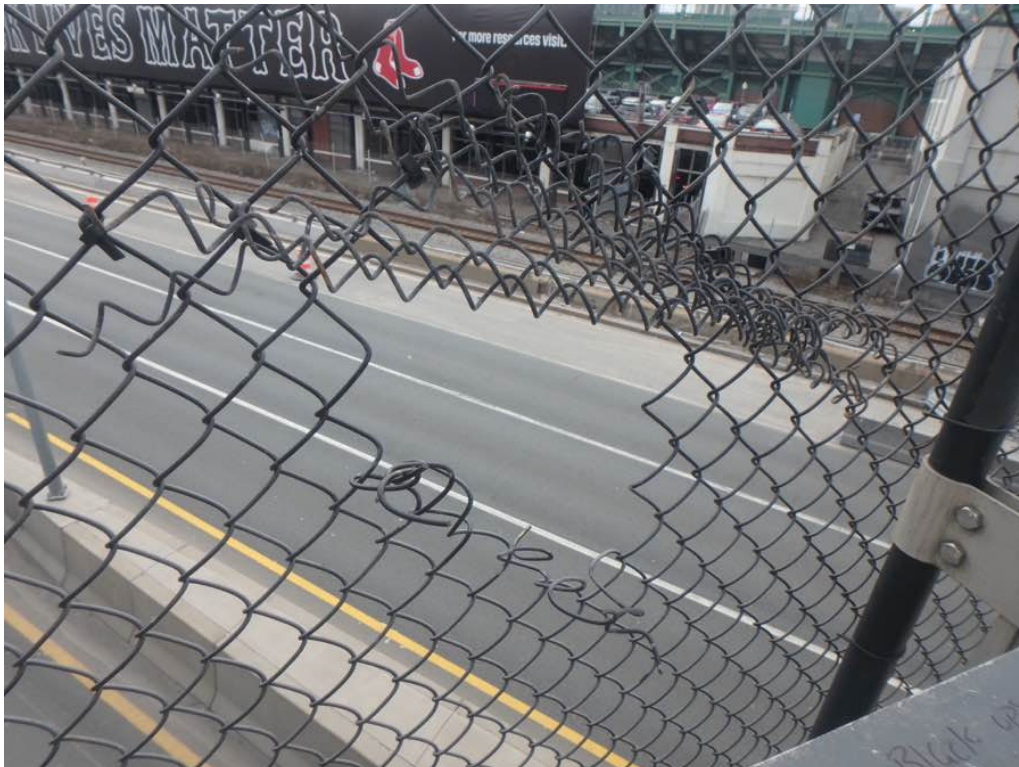
Photo 10: The east anti-missile fence has a hole in the fabric just north of post #24

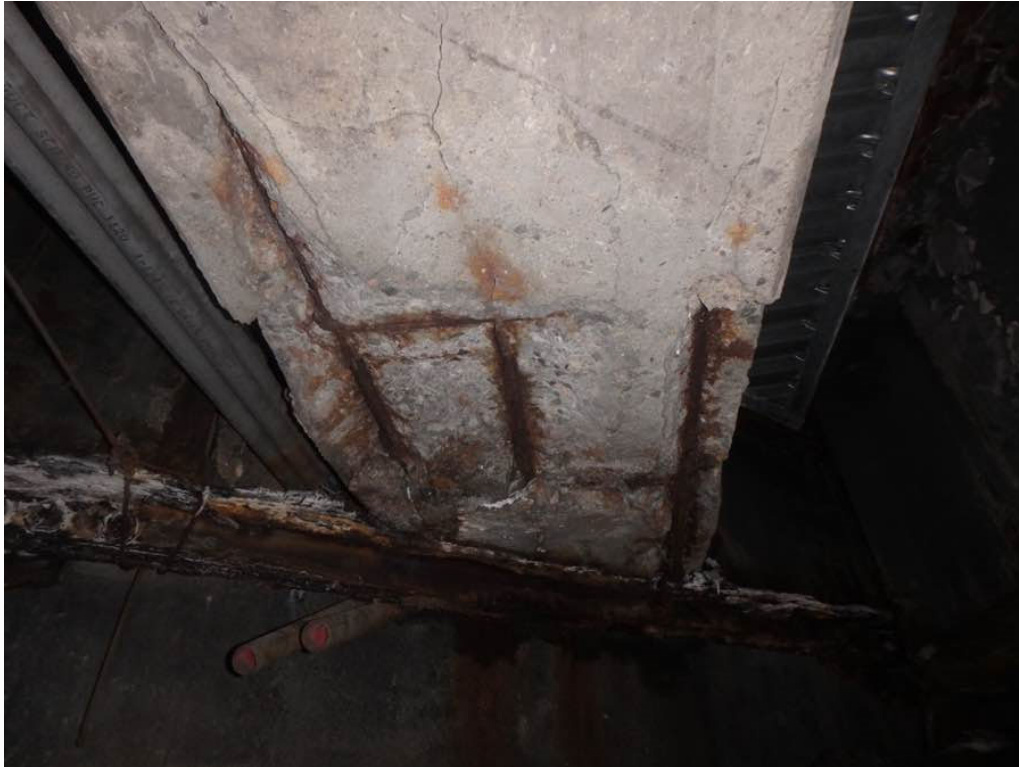
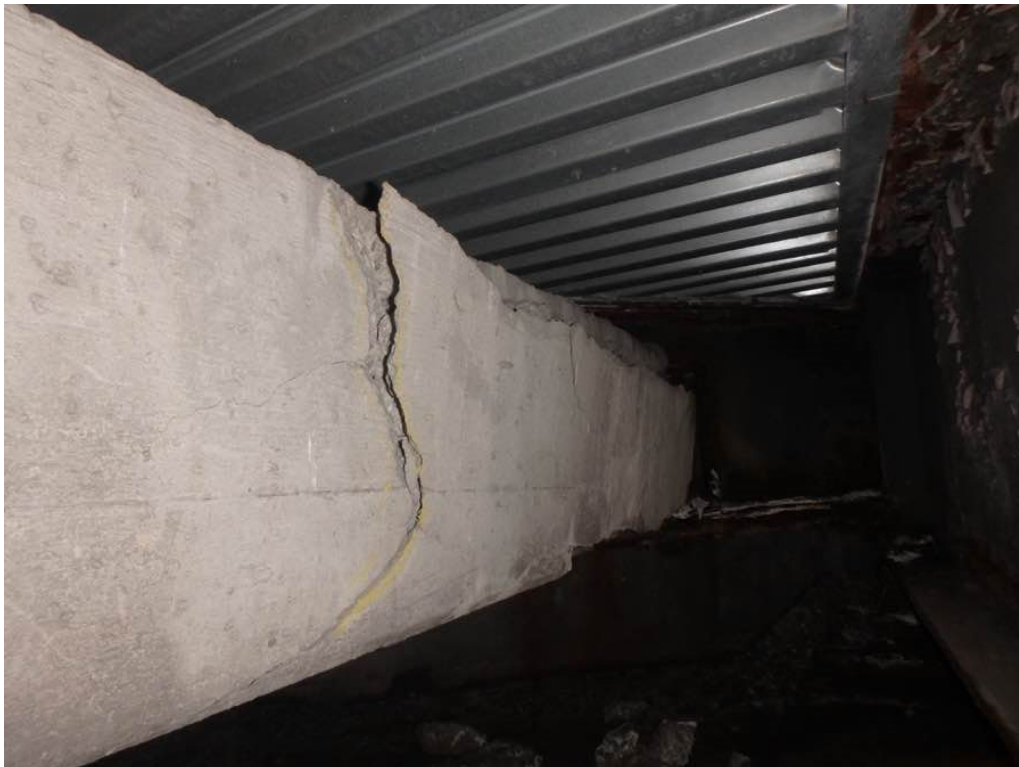
At the south abutment there is moderate spalling with exposed rusted rebar on the bottom face. The west face has a heavy vertical crack with adjacent delamination 10' out from the south abutment. **See Photos #11**

Photo 11: The concrete encased utility in bay #7 has moderate spalling with exposed rusted rebar to the bottom face over the south abutment in span #1

Photo 12: The concrete encased utility in bay #7 has heavy delamination to the west face over the south abutment in span #1

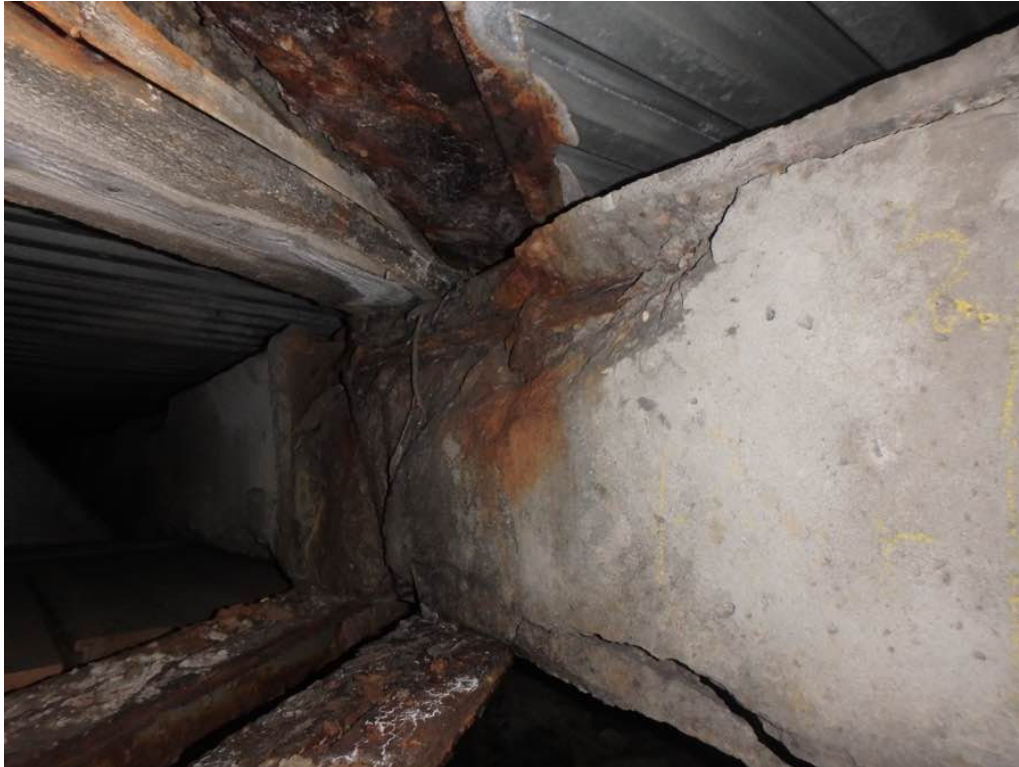
and #12. There is moderate to heavy spalling with exposed rusted rebar on the west face at pier #1. **See Photo #13.**

Photo 13: The concrete encased utility in bay #7 has moderate to heavy spalling with exposed rusted rebar to the west face over pier #1 in span #1

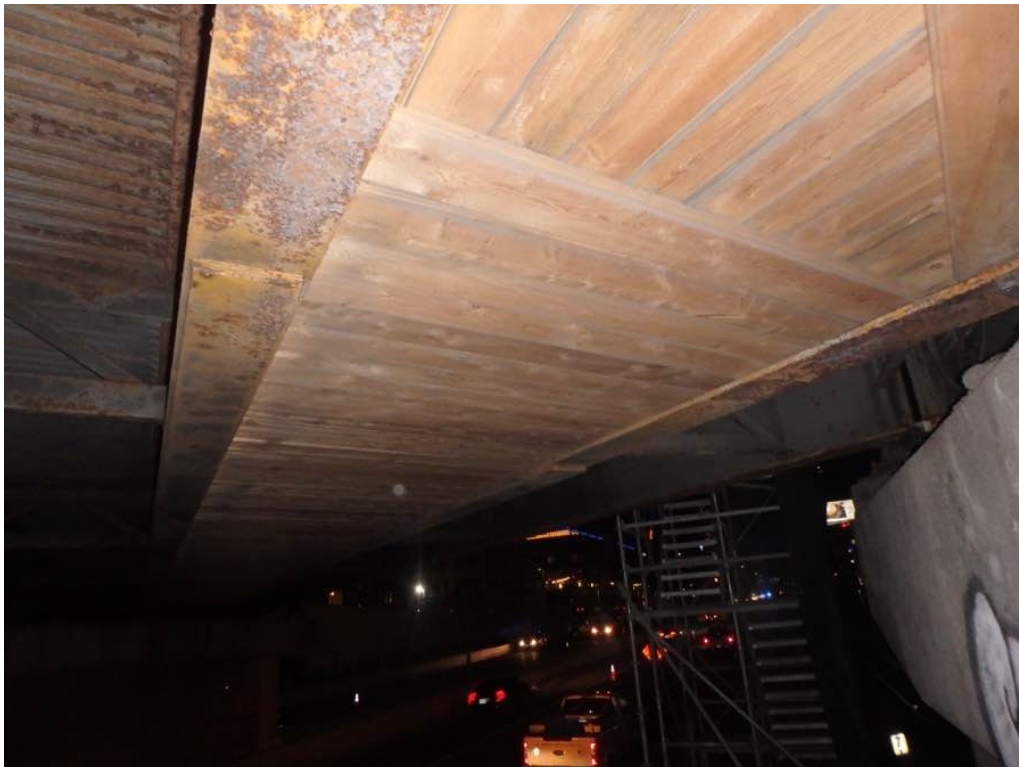
There is new timber shielding in place throughout the entire span. **See Photo #14.** There is moderate to heavy spalling with exposed rusted rebar at the bottom corner of the west face and bottom face at pier #1. At the top of the west face there is moderate to heavy spalling with exposed rusted rebar at pier #1. Above the right travel lanes there is moderate to heavy spalling with exposed rusted rebar on the west face at the top. On the east face there is also light to moderate cracking. There is heavy spalling with exposed rusted rebar at the top face and west face at pier #2. On the east face, above the second and third lane skip lines, there is a moderate spall with exposed rusted rebar. On the east face at the top and bottom corners south of pier #2, there is moderate to heavy spalling with exposed rusted rebar.

Photo 14: The concrete encased utility in bay #7 has new timber shielding in span #2

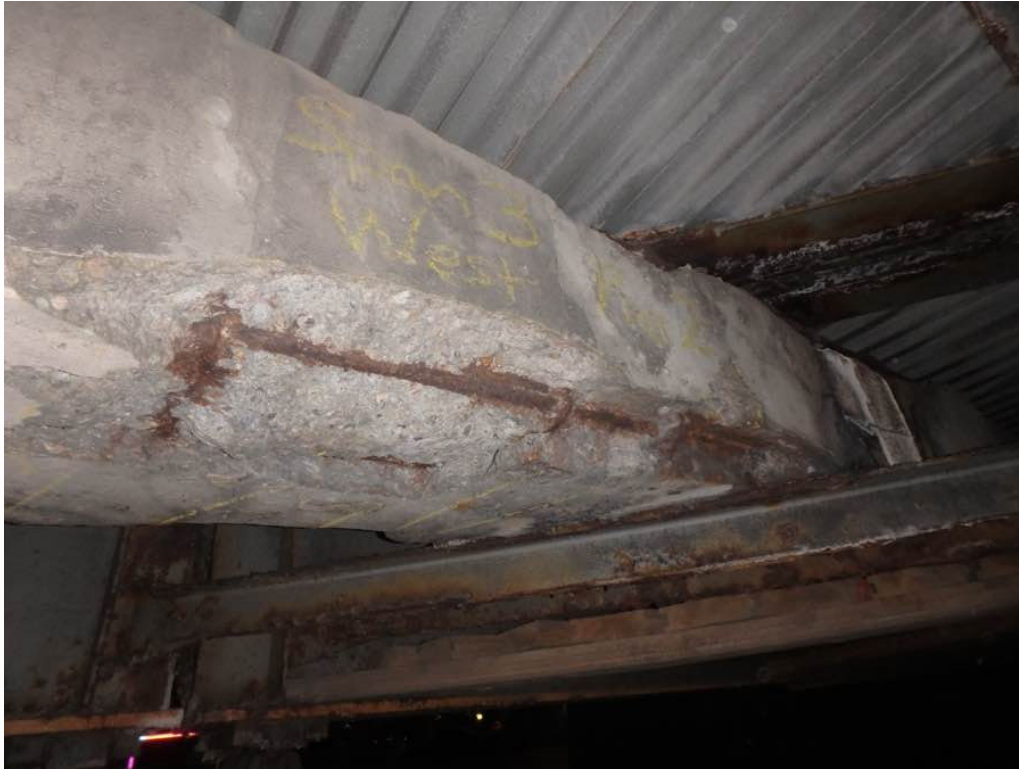
There is moderate spalling with exposed rusted rebar at the bottom west corner at pier #2. At pier #2 there is moderate to heavy spalling with exposed rusted rebar at the top corner of the west face. **See Photo #15.** On the east face, there are numerous hairline to light horizontal cracks at the top, moderate spalling with exposed rusted rebar at the bottom north of pier #2. On the bottom face there is light cracking and delamination at pier #2. Above the right two travel lanes there is a light horizontal crack and hollow concrete at the top of the east face. Above timber shielding at the north abutment, there is heavy spalling with exposed rebar and exposed conduit with some areas of 100% section loss on the west and east faces.

Photo 15: The concrete encased utility in bay #7 has moderate to heavy spalling with exposed rusted rebar at the top and bottom of the west face and hollow concrete on the bottom face over pier #2 in span #3

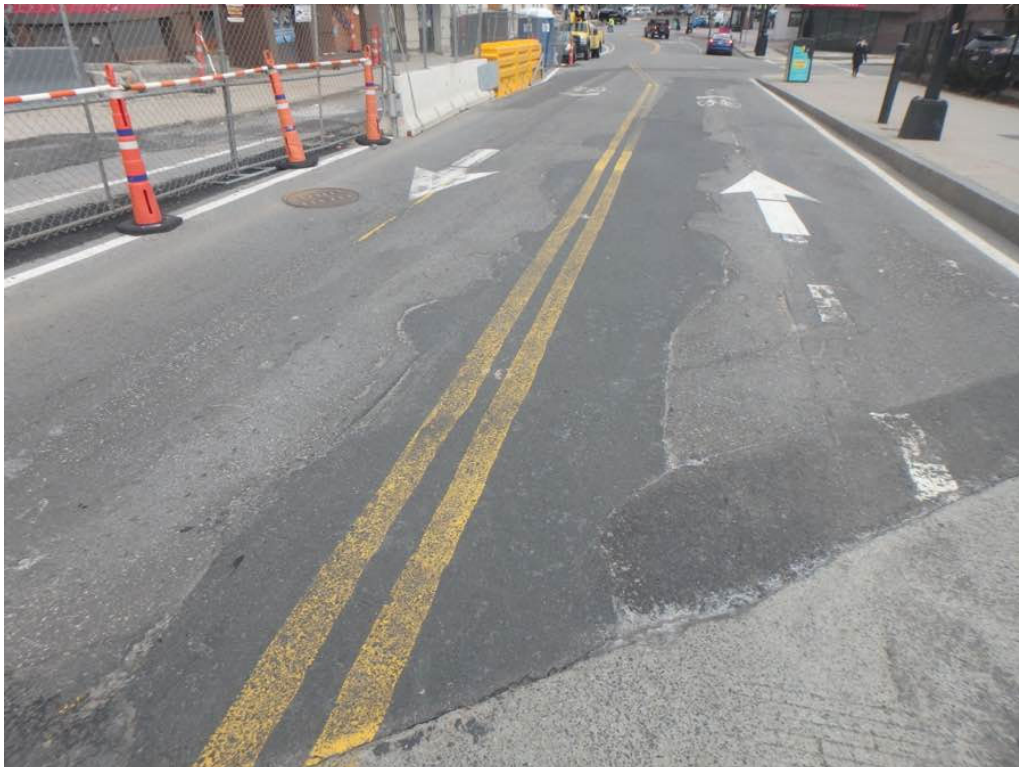
Photo 16: The north approach, bituminous patching down middle of roadway

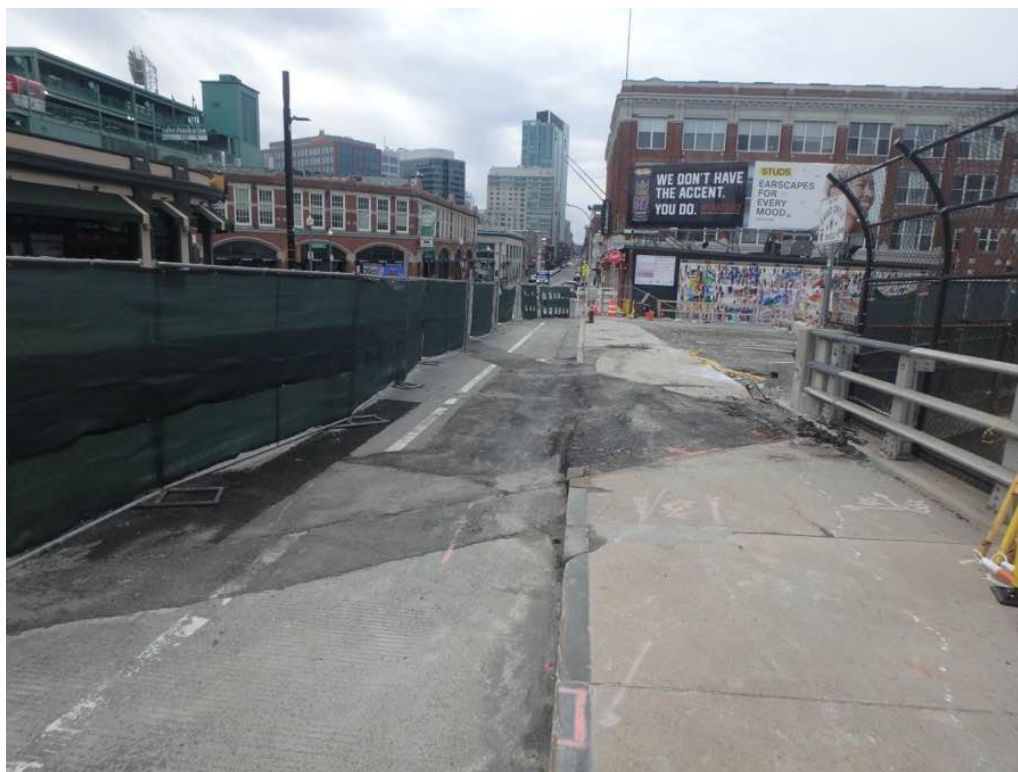
Photo 17: West sidewalk and part of travel lane, closed to pedestrian and vehicle traffic due to ongoing construction at parcel 12 (Southwest approach shown)

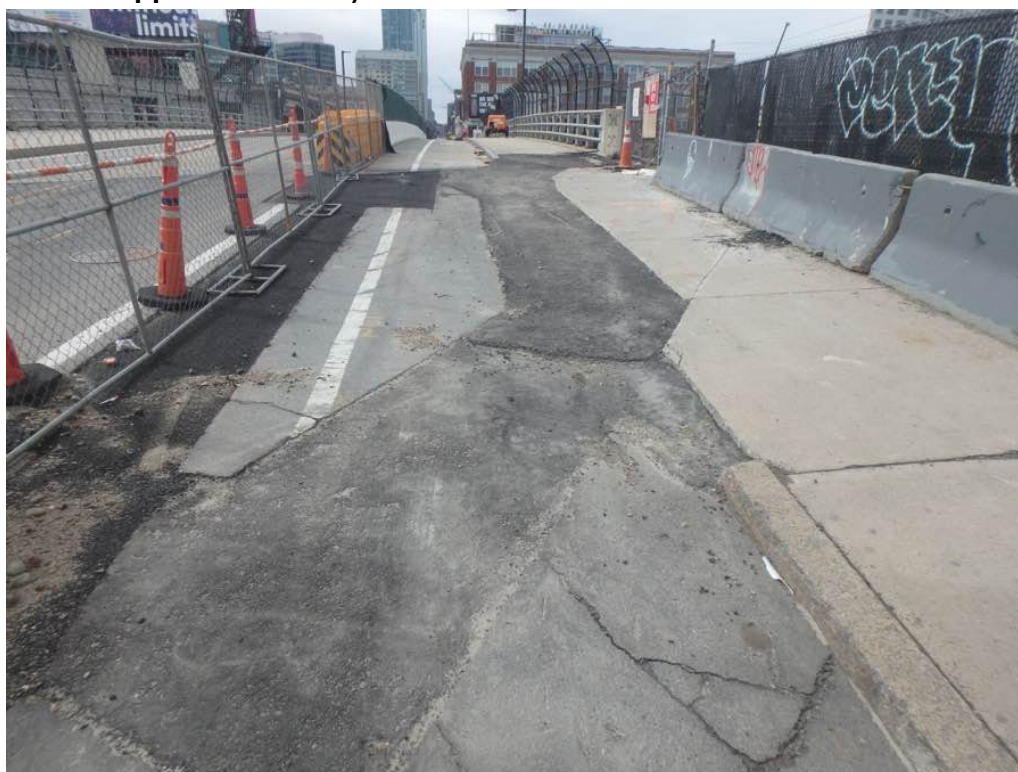
Photo 18: Northwest approach sidewalk closed to pedestrians due to ongoing construction

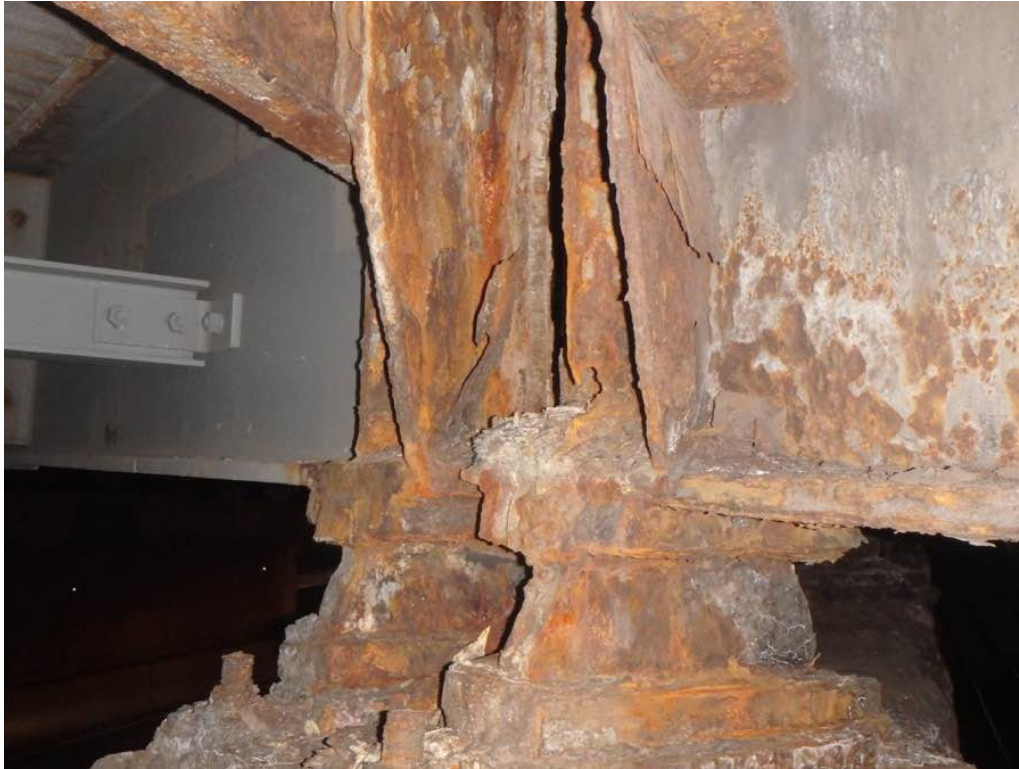
Photo 19: Small area of 100% section loss in the bottom of the west vertical stiffener of beam #2 over pier #1

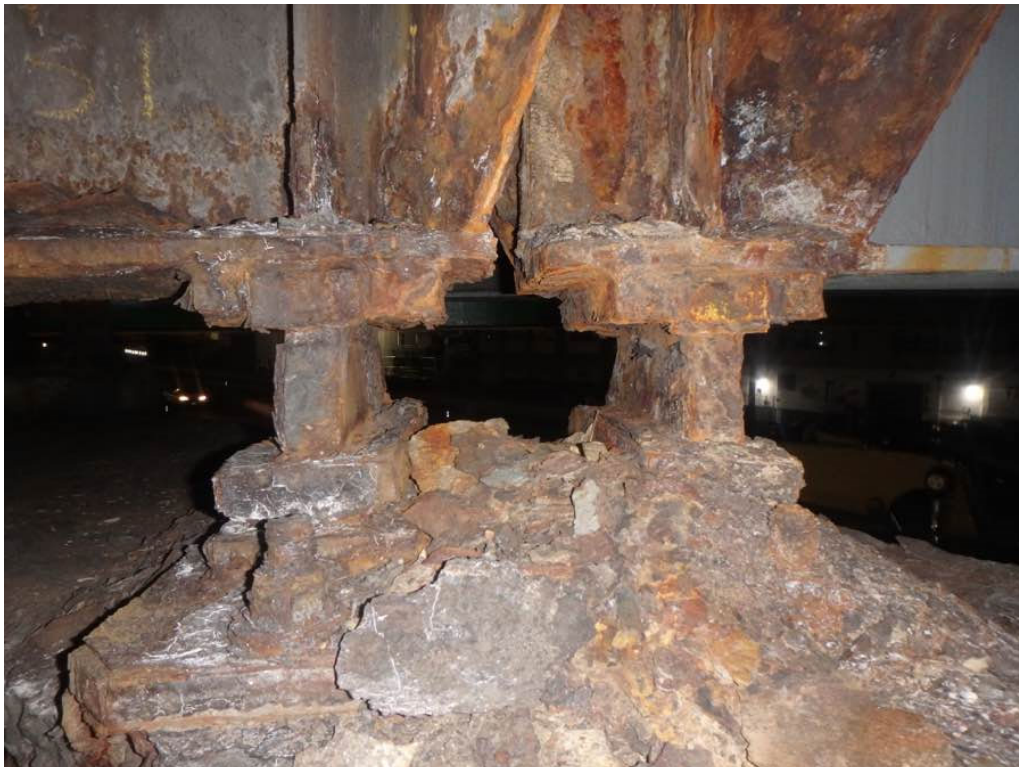
There is moderate to heavy rusting and minor to moderate pack rust of the bearings. **See Photo #20.**

Photo 20: Typical rusting of the bearings over pier #1, several with hardened concrete debris impacting the bearings (bearings #2 and #11 shown)

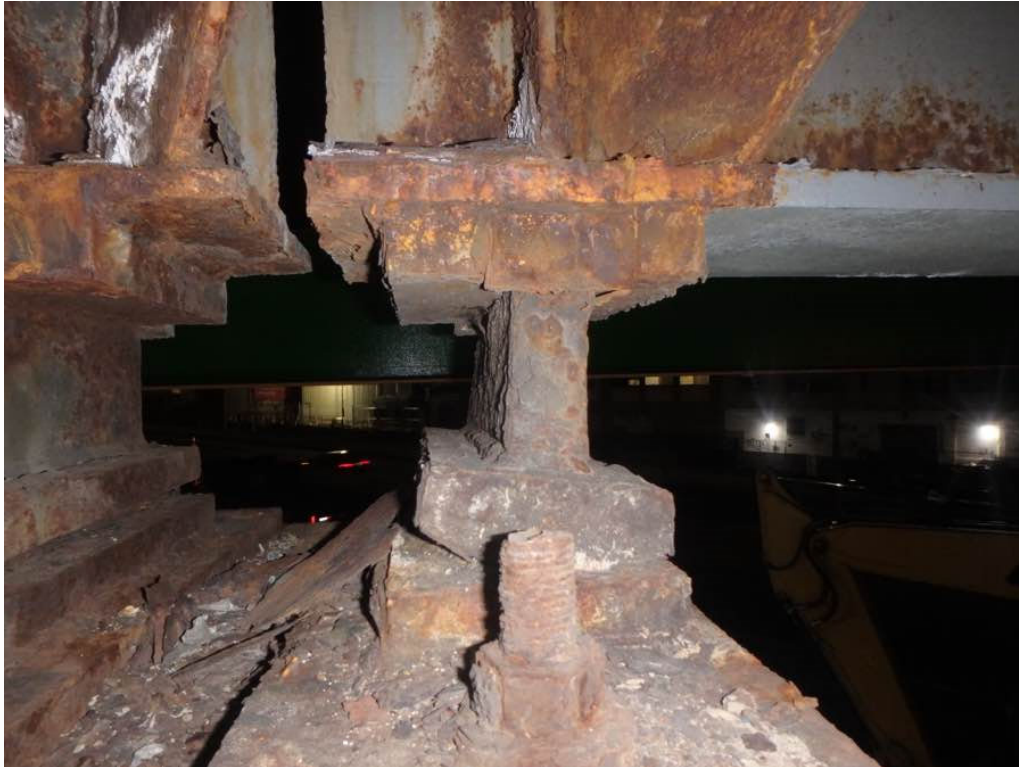
Photo 21: The bearing for beam #10 at pier #1, span #2, is tilted up to 1" to the north

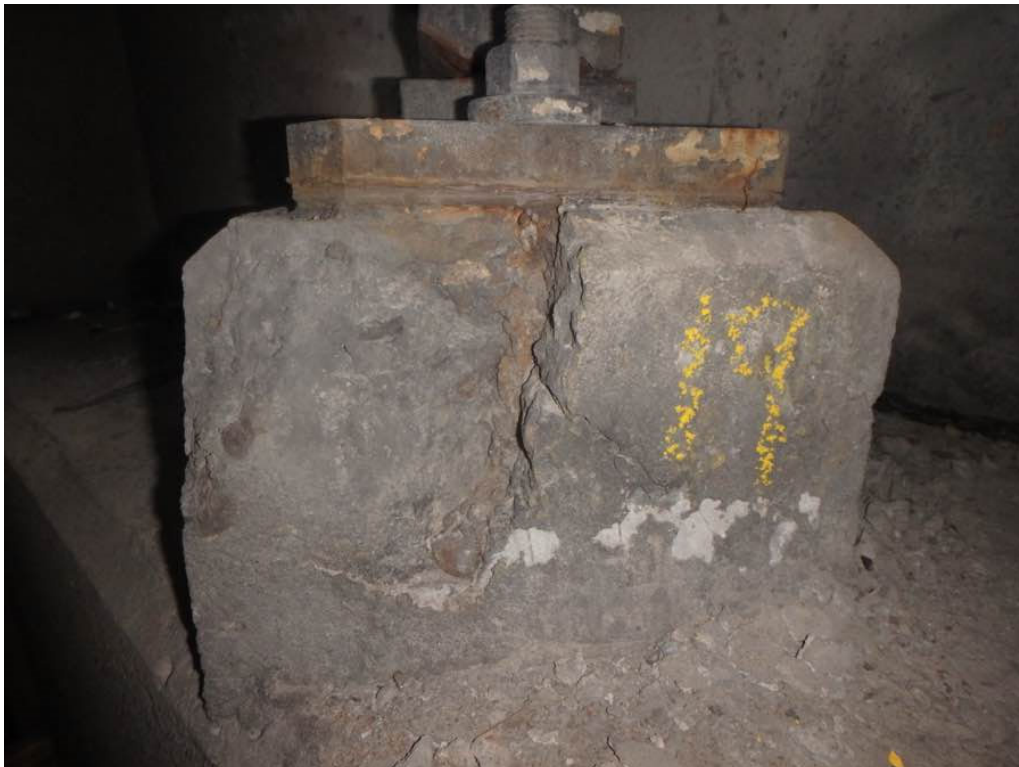
North Abutment
There is minor to moderate spalling with slight undermining on the east face below beam #19. **See Photo #22.**
Below beam #21 there is light vertical cracking on the east face.
There is a moderate spall on the east face below beam #26.
Below most beams there are light vertical cracks in the pedestals.

Photo 22: There is minor to moderate spalling of the pedestal for beam #19 at the north abutment

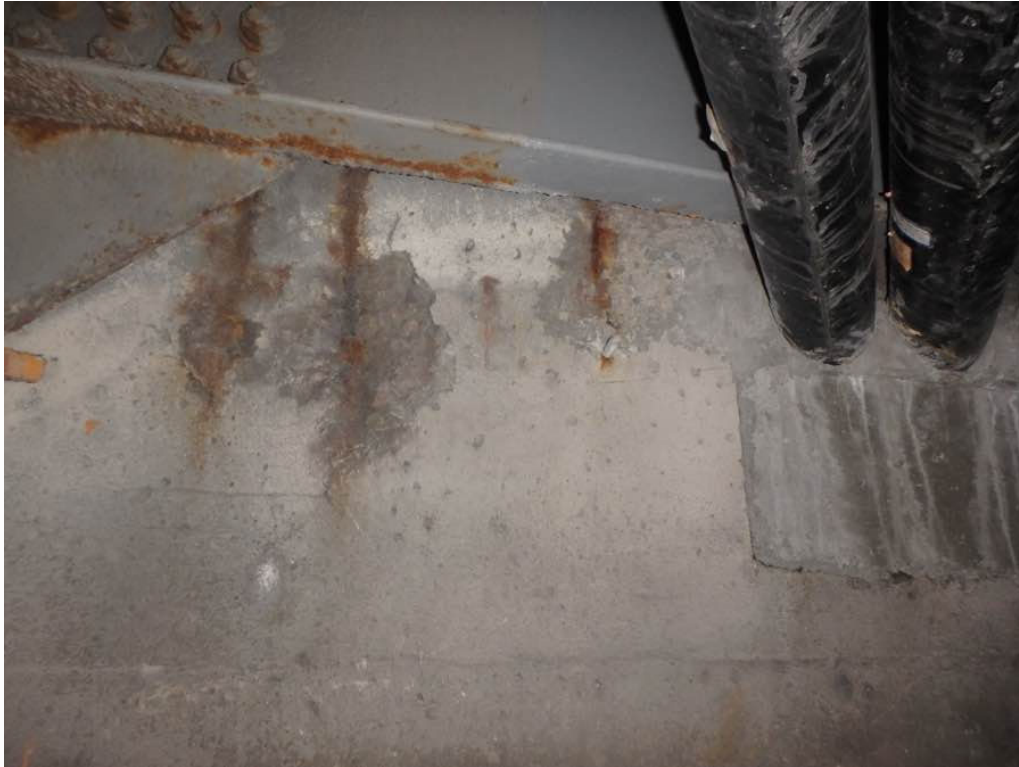
There are two moderate spalls with exposed rusted rebar between beams #19 and #20. **See Photo #23.**

Photo 23: There are two moderate spalls with exposed rusted rebar at the north backwall between beams #19 and #20 (bay #1)

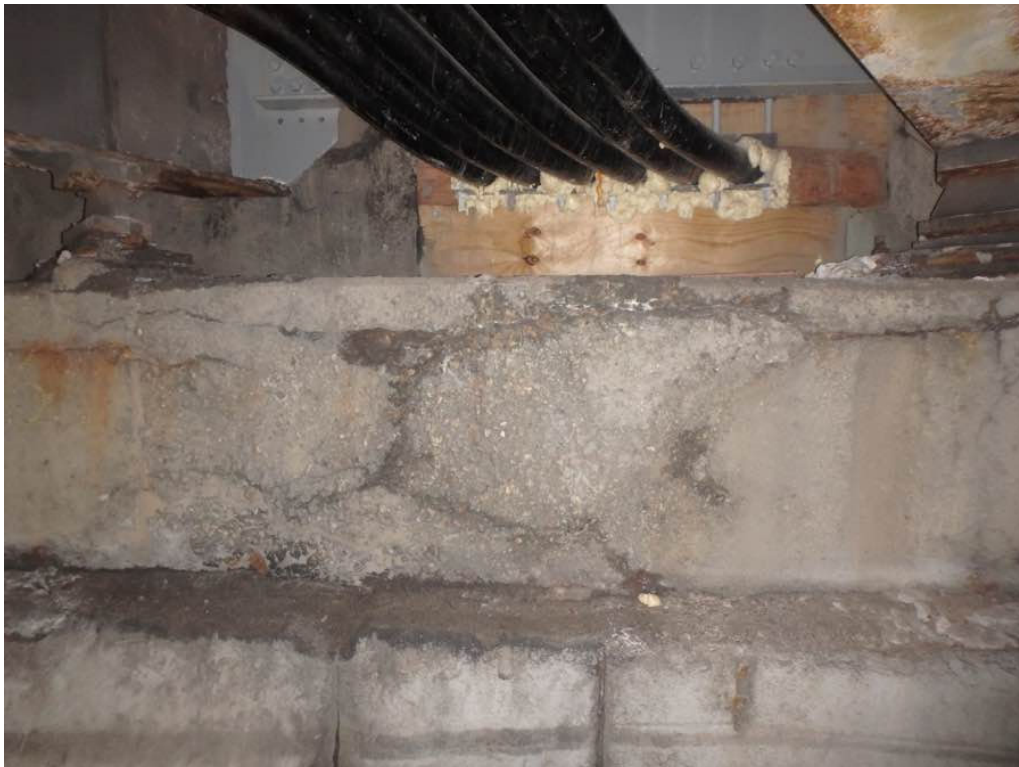
There is moderate horizontal cracking, hollow concrete, and minor spalling with exposed rusted rebar between beams #5 and #6. **See Photo #24.**

Photo 24: There is moderate horizontal cracking, hollow concrete, and minor spalling with exposed rusted rebar at the north face of the south breastwall between beams #5 and #6

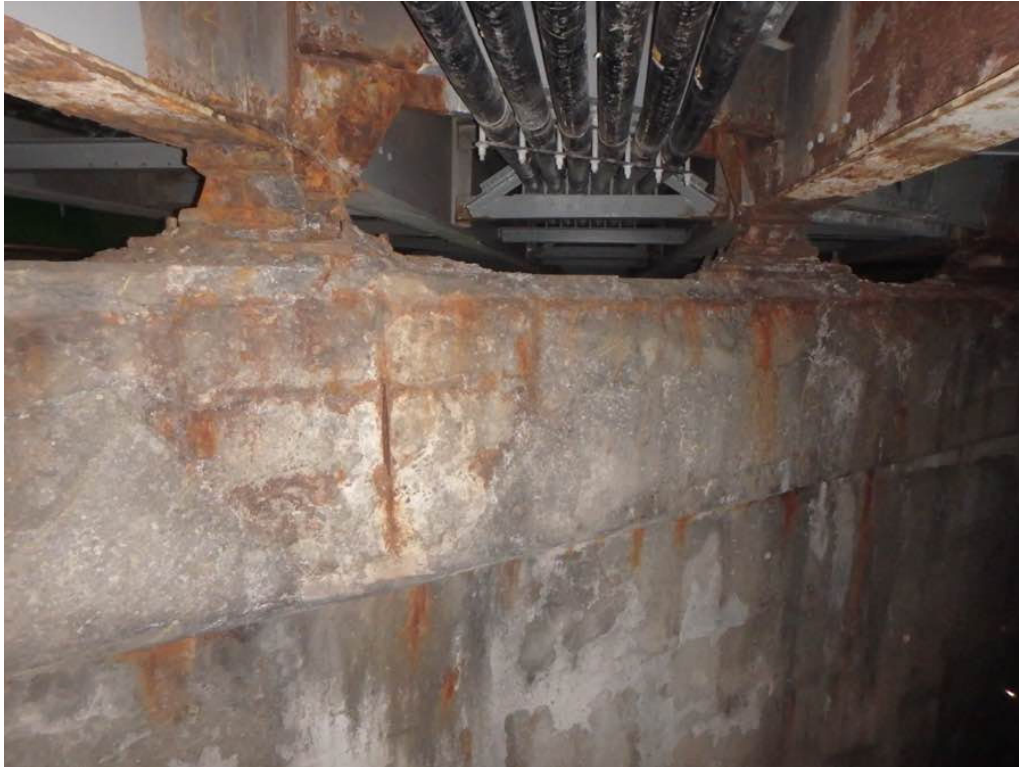
Photo 25: There is moderate spalling with exposed rusted rebar and adjacent delamination and cracking to the south face of the pier #1 pier cap below beam #2 (extending to beam #4 at the top corner)

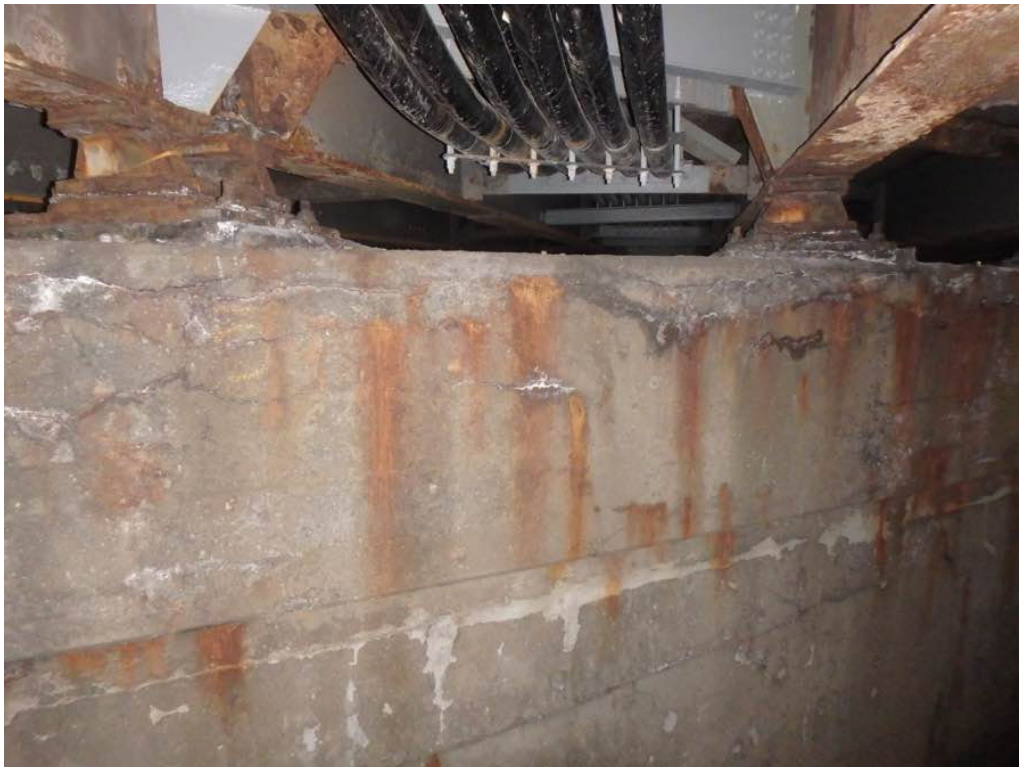
Photo 26: There is moderate horizontal cracking and delamination to the top corner of the south face of the pier #1 pier cap. Between beams #5 and #6 shown
